Manhole Inspection Summary

Manhole # S65O__001MH

Location Address: **6120 Boston St.**

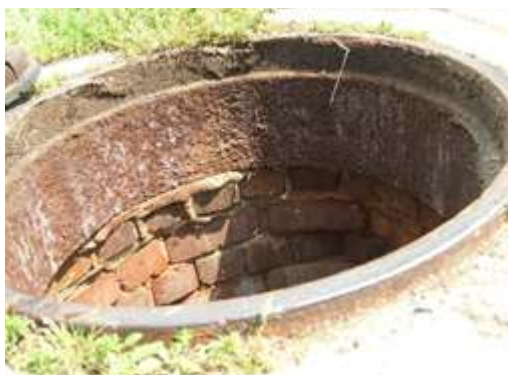
Defect 2

Diameter: **24** (in.) Length: (in.) Dist A/B Grade: **1** (in.)

above grade

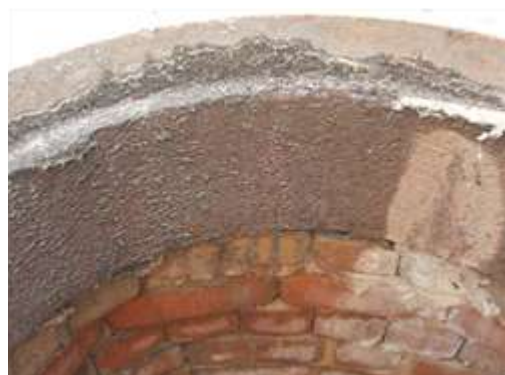
Defect 3

Infiltration: ☐ None ☒ **Joint** ☐ Cracks ☒ **Mortar** ☐ Roots ☐ Wall

infiltration

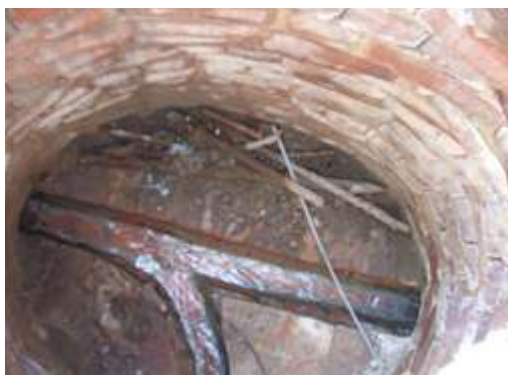
Defect 1

Condition: ☐ Sound ☐ Cracked ☐ Root Intrusion ☐ Deteriorated ☐ Leaks ☒ **Debris**

debris

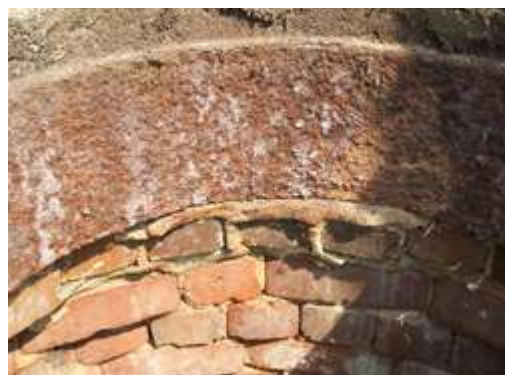
Defect 4

Condition: ☐ Sound ☐ Cracked ☐ Root Intrusion ☒ **Loose Brick** ☒ **Deteriorated**

loose bricks

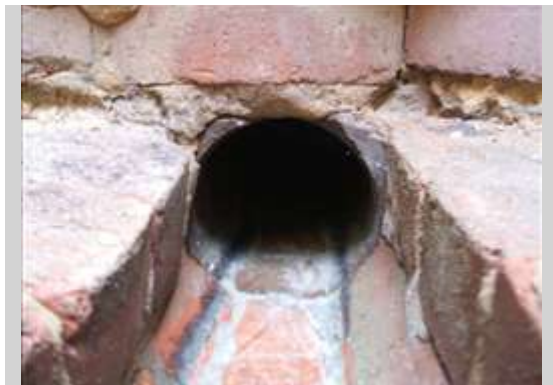
12 O'Clock Outflow

6 in. Circular Gravity Sewer
Pipe Out @ 12 O'Clock

Infiltration: **None** Pipe Seal Cond: **Sound**

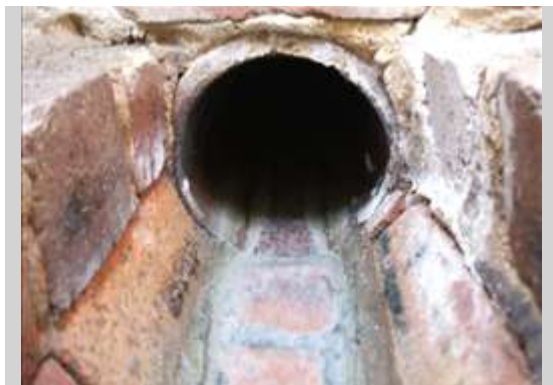
6 O'Clock Inflow

6 in. Circular Gravity Sewer
Pipe In @ 6 O'Clock

Infiltration: **None** Pipe Seal Cond: **Sound**

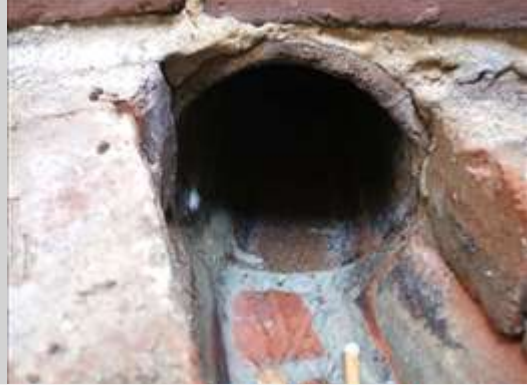
9 O'Clock Inflow

6 in. Circular Gravity Sewer
Pipe In @ 9 O'Clock

Infiltration: **None** Pipe Seal Cond: **Sound**

Connects To: **Dead End**
